PHASE I REPORT
NATIONAL DAM INSPECTION PROGRAM

Name of Dam: SCS DAM PA-419
State & State No.: PENNSYLVANIA, 64-170
County: WAYNE
Stream: TRIBUTARY TO INDIAN ORCHARD BROOK
Date of Inspection: November 7, 1979

SCS DAM PA-419

NDI-ID NO. PA-00086
DER-ID NO. 64-170

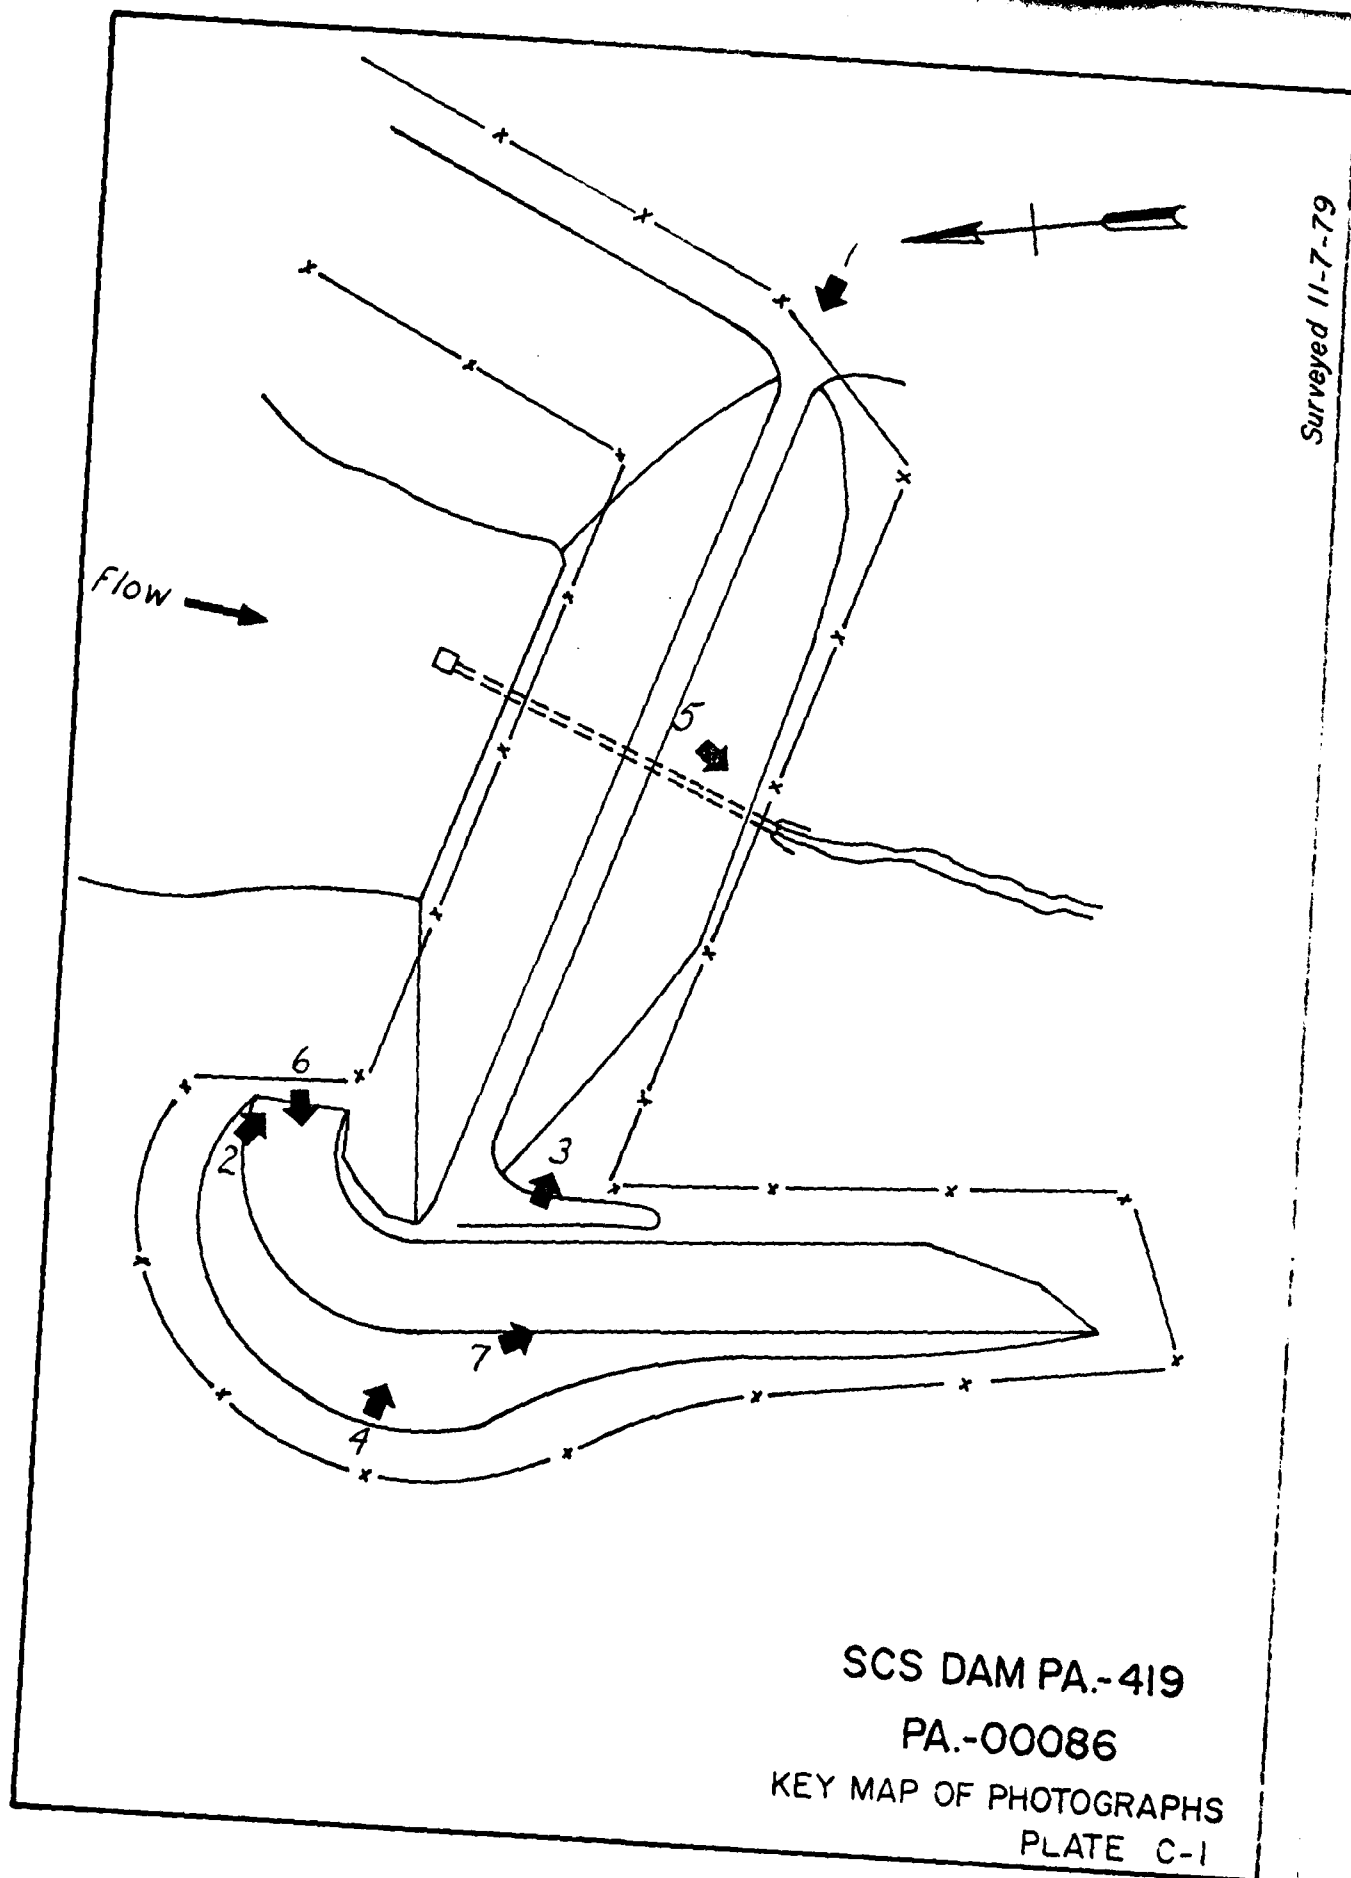
UPSTREAM SLOPE - NO. 2

The function of this dam is to detain storm water runoff and to release it slowly thus reducing the peak discharge in the downstream area. Storage, therefore, is its prime function. Most of its upstream slope is exposed. The upstream slope is in good condition and is protected with riprap up to an elevation of 5 feet above normal pool level.
